INSPECTION REPORT

123 Sample Ln, Newburgh, Indiana 47630

Inspection Date **Jan 19, 2023**

Company **Worman Home Inspections
LLC**

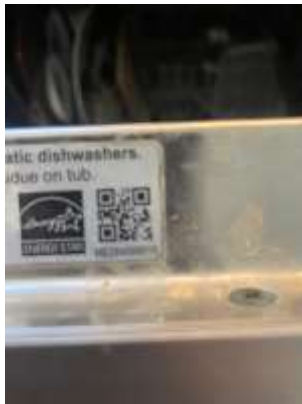
Excessively dirty and/or has mineral deposits

An excessively dirty dishwasher may not fully clean dishes

Soak and clean with a calcium deposit removal product

such as CLR

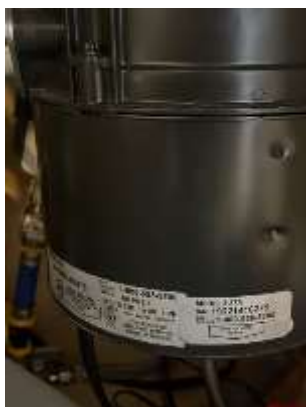
Not recommended with septic system

With a garbage disposal, food particles are released into the septic system. They do not break down as fast or at all, thereby clogging the system increasing the servicing needs

Remove the garbage disposal

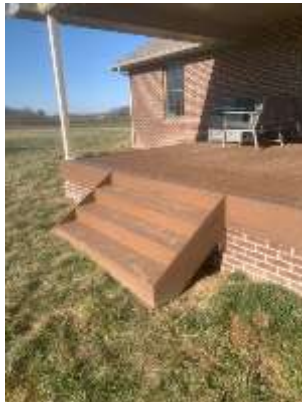
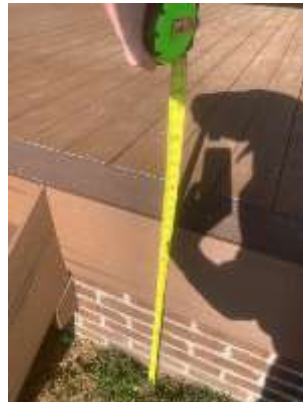
📍 Exterior: Ground View

No handrail

Handrail shall be installed on every flight of stairs which is more the. Three risers high.

Have qualified contractor install handrail for stairs.

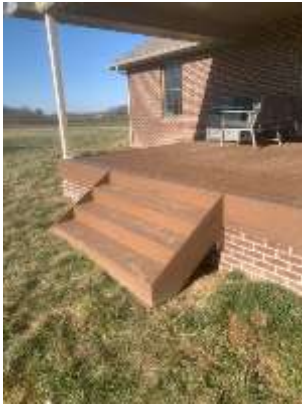
Handrail is missing

A missing handrail could hinder the stair user an opportunity to stop or reduce the extent of a fall

Install a handrail

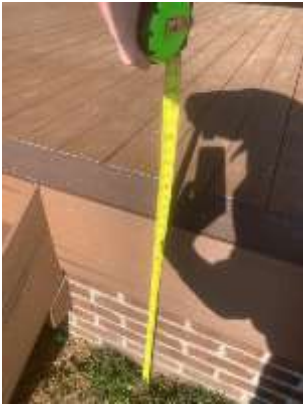
No guardrail

Guardrails should be installed on porch, landing and balcony which is more than 30 inches above floor or grad below.

Have qualified contractor install guardrail.

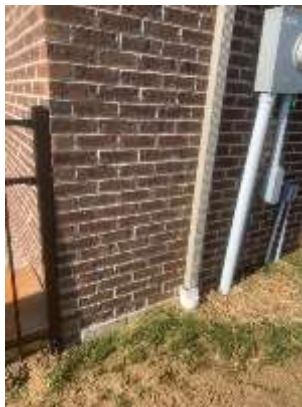
Exterior: Ground View

Elbow(s) are not properly connected

Improper connections prevent water drainage is not optimally contained

The elbow connector should be securely fastened to prevent the elbow from coming loose and assure a leak-free elbow

Secure or replace the elbow connector

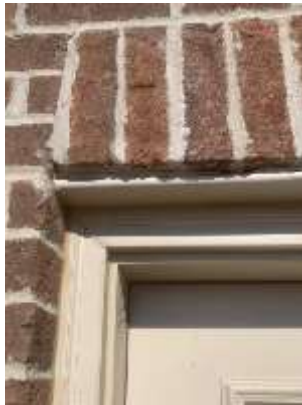
Mortar has cracks, voids or is loose

If not repaired, the cracking may worsen resulting in moisture intrusion which could lead to further problems such as insect nesting and damage to the siding material

This could be caused by shifting of the siding material and/or improper installation

Have a qualified mason repair the affected area

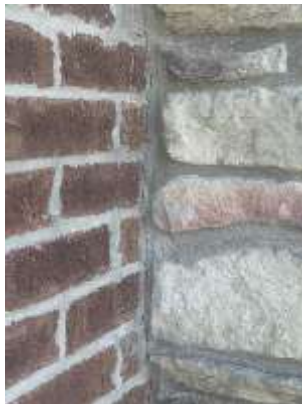
Joints are separating

The gaps provide no protection against insect intrusion and adversely affect the thermal barrier of the home, potentially increasing utility costs

Have repaired by a qualified siding contractor

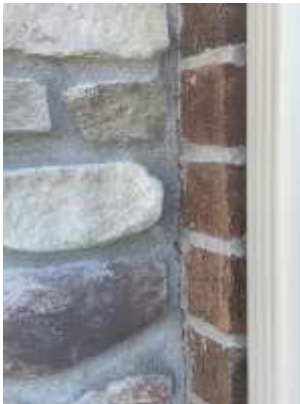
Brick is cracked

If not repaired, the cracking may worsen resulting in moisture intrusion further deteriorating the brick

The cracking could be caused by foundation movement, moisture intrusion, improper installation, failure under external pressure such as tree roots and improper structural support

Have a qualified mason repair the affected area

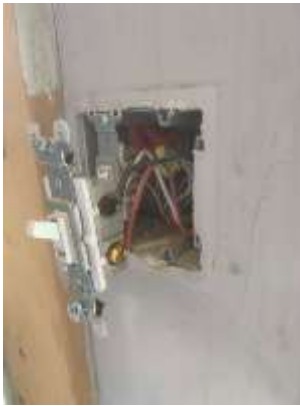
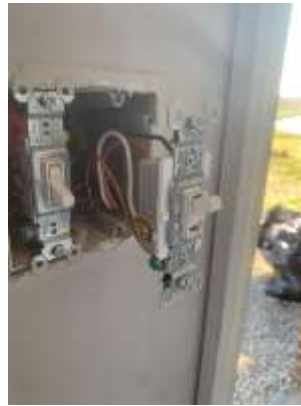
Has open wires

Exposed energized wiring can be hazardous to touch

Have repaired by a licensed electrician

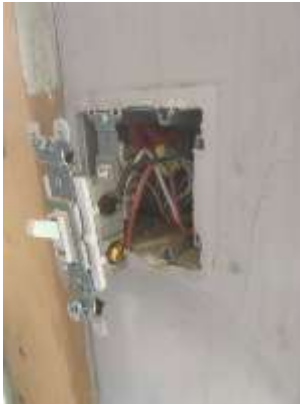
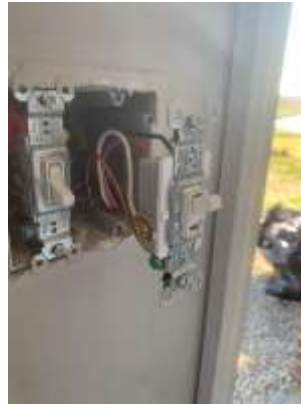
Cover plate is missing

Without a cover plate, electrical shock may result if touched

Install a cover

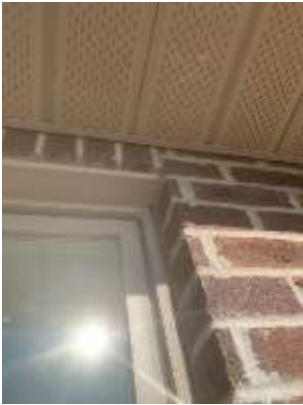
MINOR CONCERN Caulking or sealant is deteriorated	
IMPACT	Without proper caulking, air, moisture and/or insect intrusion may occur
SUGGESTED ACTION	Re-caulk all windows and doors where caulking has deteriorated
PHOTOS
